Manhole Inspection Summary

Manhole # S55C__020MH

Location Address: **3707 e baltimore st**

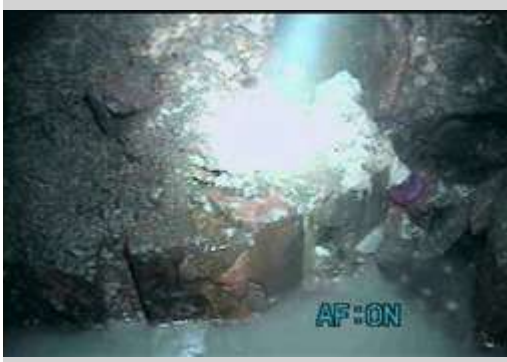
Defect 4

Condition: ☐ Sound ☐ Cracked ☐ Root Intrusion ☐ Deteriorated ☐ Leaks ☒ **Debris**

channel debris

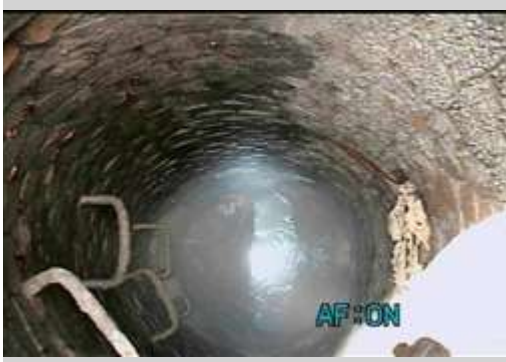
Defect 5

Infiltration: ☐ None ☐ Joint ☐ Cracks ☐ Mortar ☐ Roots ☒ **Wall**

Corbel and barrel wall infiltration

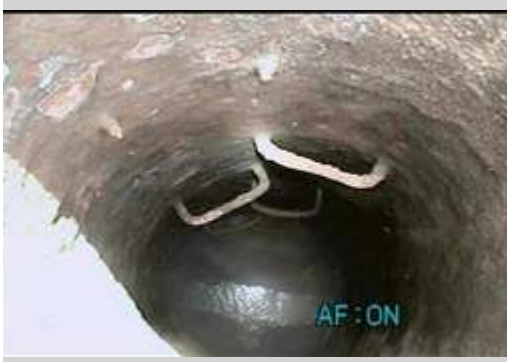
Defect 3

Count: **10** Missing: **1** ☒ **Corroded**

steps

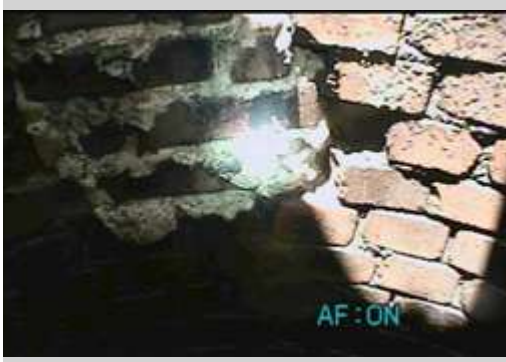
Defect 2

Condition: ☐ Sound ☐ Cracked ☐ Root Intrusion ☒ **Loose Brick** ☐ Deteriorated

corbel loose bricks.

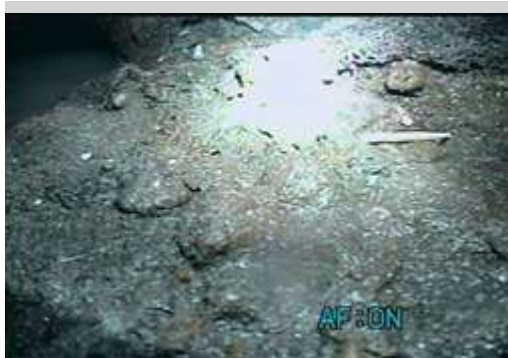
Defect 1

Condition: ☐ Sound ☐ Cracked ☐ Root Intrusion ☐ Deteriorated ☐ Leaks ☒ **Debris**

bench debris

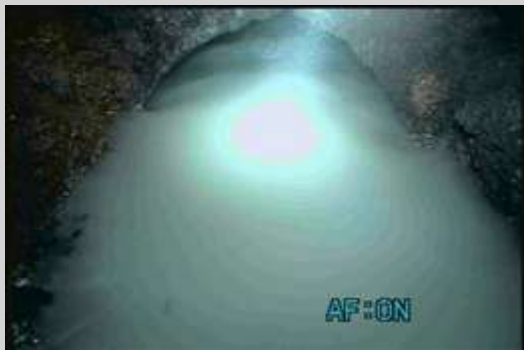
12 O'Clock Outflow

8 in. Circular Gravity Sewer
Pipe Out @ 12 O'Clock

Invert Depth: **18.03** (ft.) Flow Characteristics: **Slow**

Deposits: ☒ None ☐ Mud ☐ Sludge ☐ Debris ☐ Grease

Infiltration: **None** Pipe Seal Cond: **Unknown**

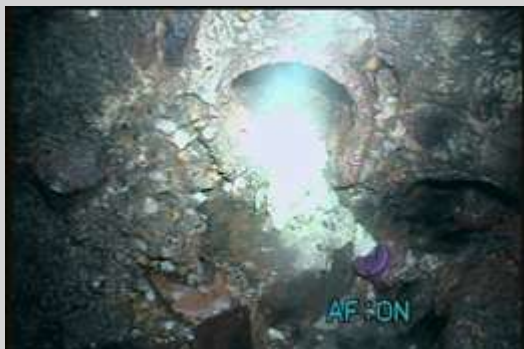
2 O'Clock Inflow

6 in. Circular Gravity Sewer
Pipe In @ 2 O'Clock

Invert Depth: **17.93** (ft.) Flow Characteristics: **Slow**

Deposits: ☒ None ☐ Mud ☐ Sludge ☐ Debris ☐ Grease

Infiltration: **None** Pipe Seal Cond: **Unknown**

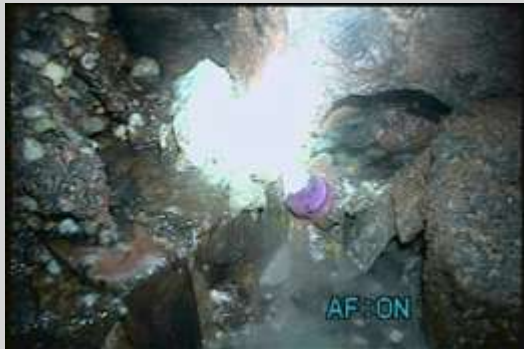
3 O'Clock Inflow

8 in. Circular Gravity Sewer

Pipe In @ 3 O'Clock

Invert Depth: 17.96 (ft.) Flow Characteristics: **None**

Deposits: ☒ None ☐ Mud ☐ Sludge ☐ Debris ☐ Grease

Infiltration: **None**

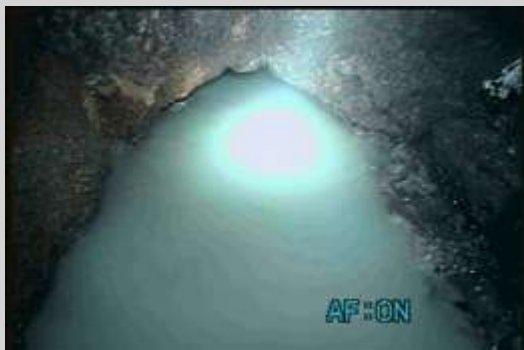
6 O'Clock Inflow

8 in. Circular Gravity Sewer

Pipe In @ 6 O'Clock

Invert Depth: 17.98 (ft.) Flow Characteristics: **Slow**

Deposits: ☒ None ☐ Mud ☐ Sludge ☐ Debris ☐ Grease

Infiltration: **None**
